# Amazon Distribution Center Restoration Case Study

Knight Commercial | Amazon Distribution Center

Balch Springs, TX — Distribution Center

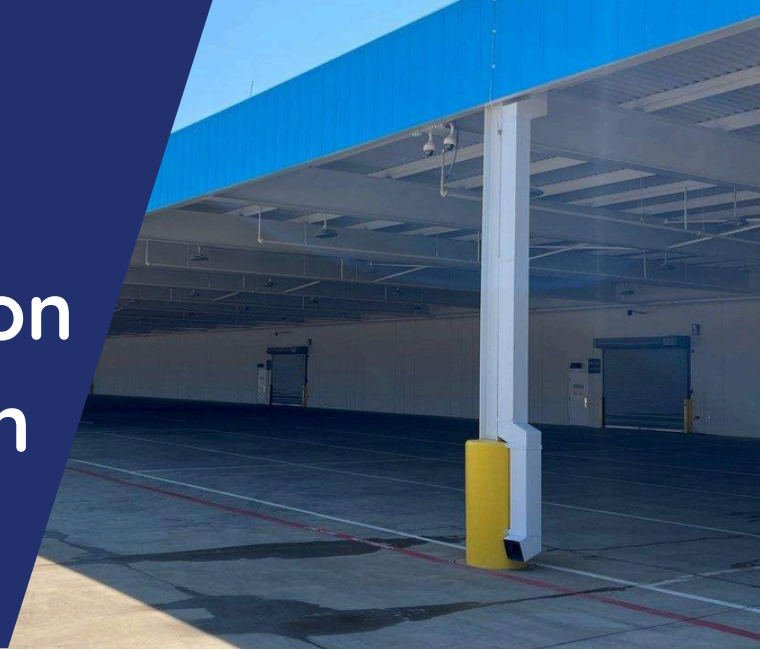
- Applied **acrylic dry-fall coating** with rust-inhibitive pigments, 6 mil thickness, rated for C3 environments, providing **10+ years of protection**.
- Used **rapid-cure coatings** to allow other trades to re-enter within hours.
- Utilized **SSPC-SP-3 power tool cleaning** to restore damaged steel members instead of replacing them.
